THE NATURE AND CAUSES OF  
COASTAL LANDSLIDING ON  
THE MAUNGATAPU PENINSULA,  
TAURANGA, NEW ZEALAND.

A thesis submitted in partial fulfilment of the  
requirements for the Degree of Master of Science  
in Earth Sciences

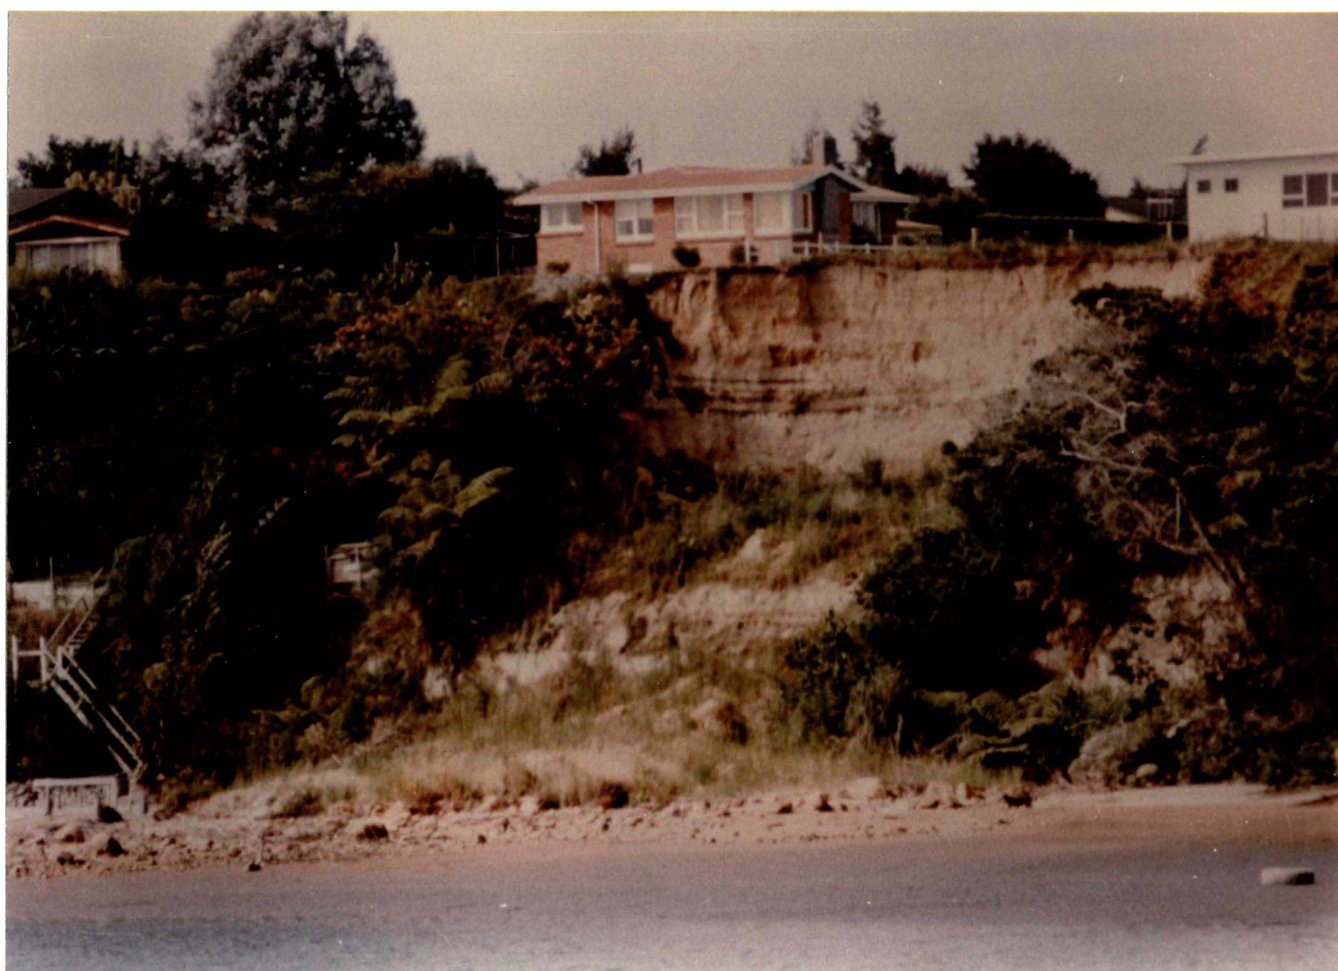
A frontal view of the landslide scar behind the Anglican church on Te Hono st., Maungatapu (Site 1).

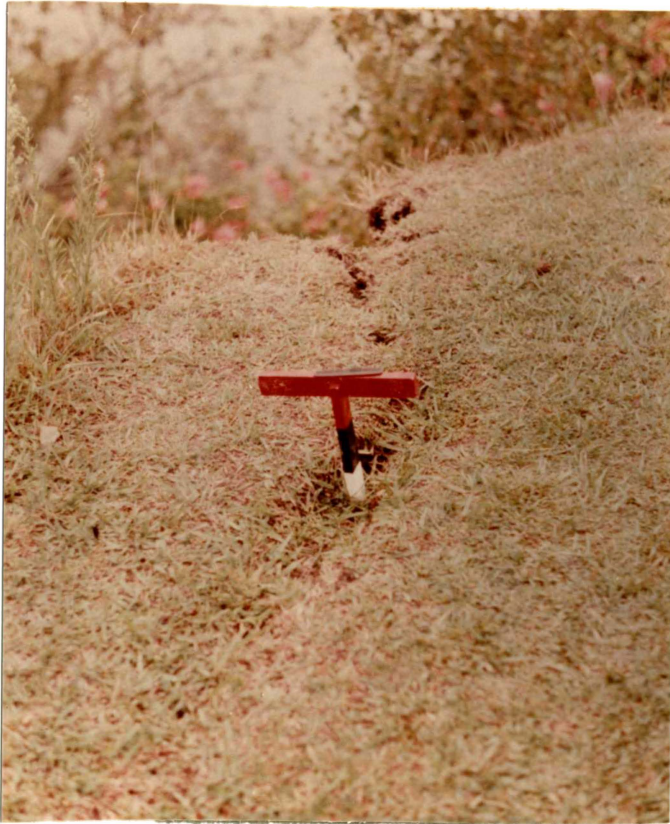
Fig. 3.10(a). 1.2 metre deep crack behind the block which toppled.

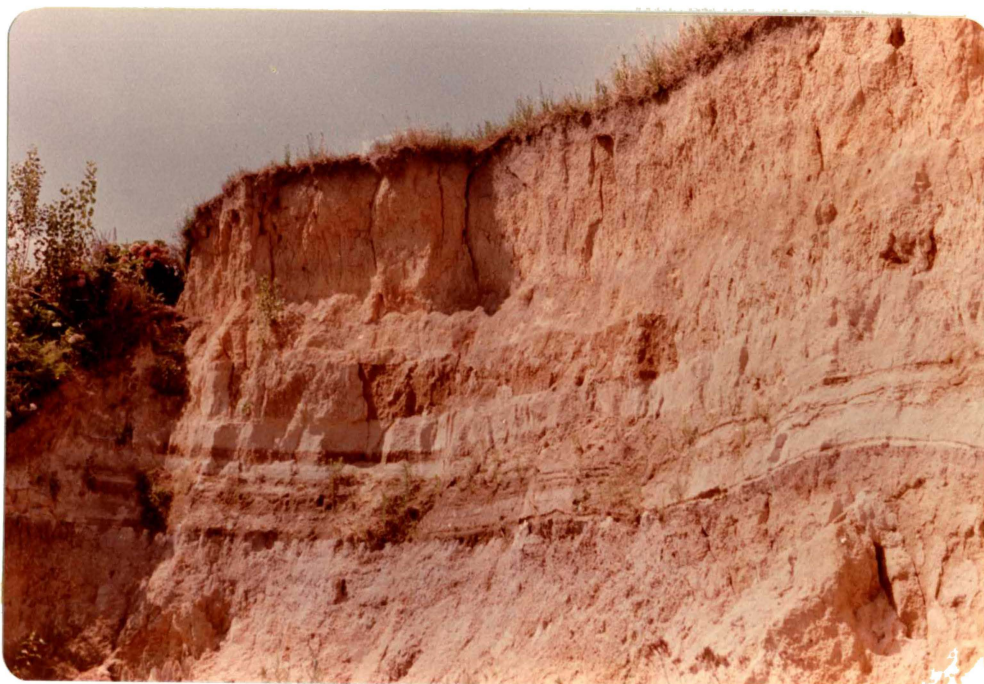
Fig. 3.10(b). The block,  
a few minutes prior to  
failure.

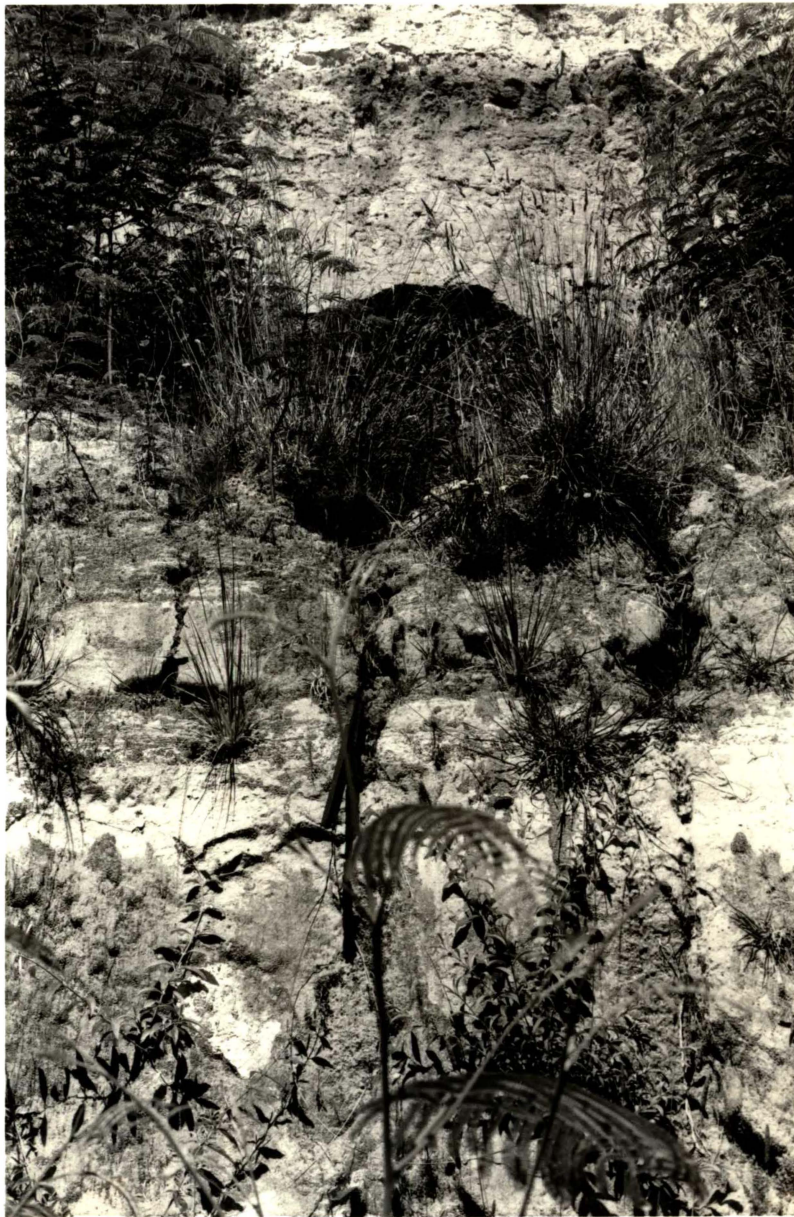
Fig. 3.11. Spalling failure at the centre of site 3.

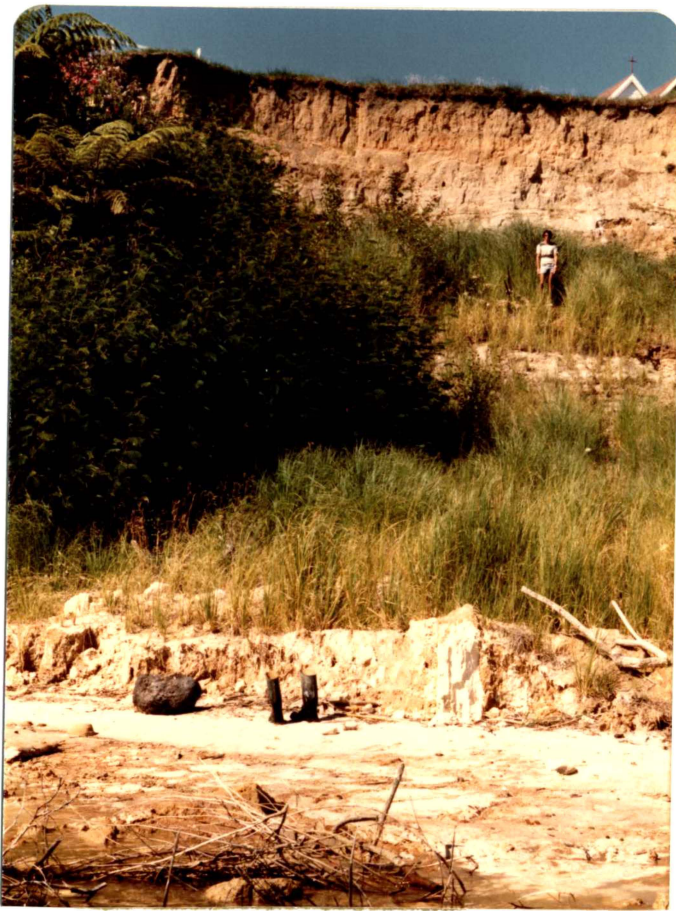
Fig. 3.13(a) Passive erosion: western side of debris lobe.

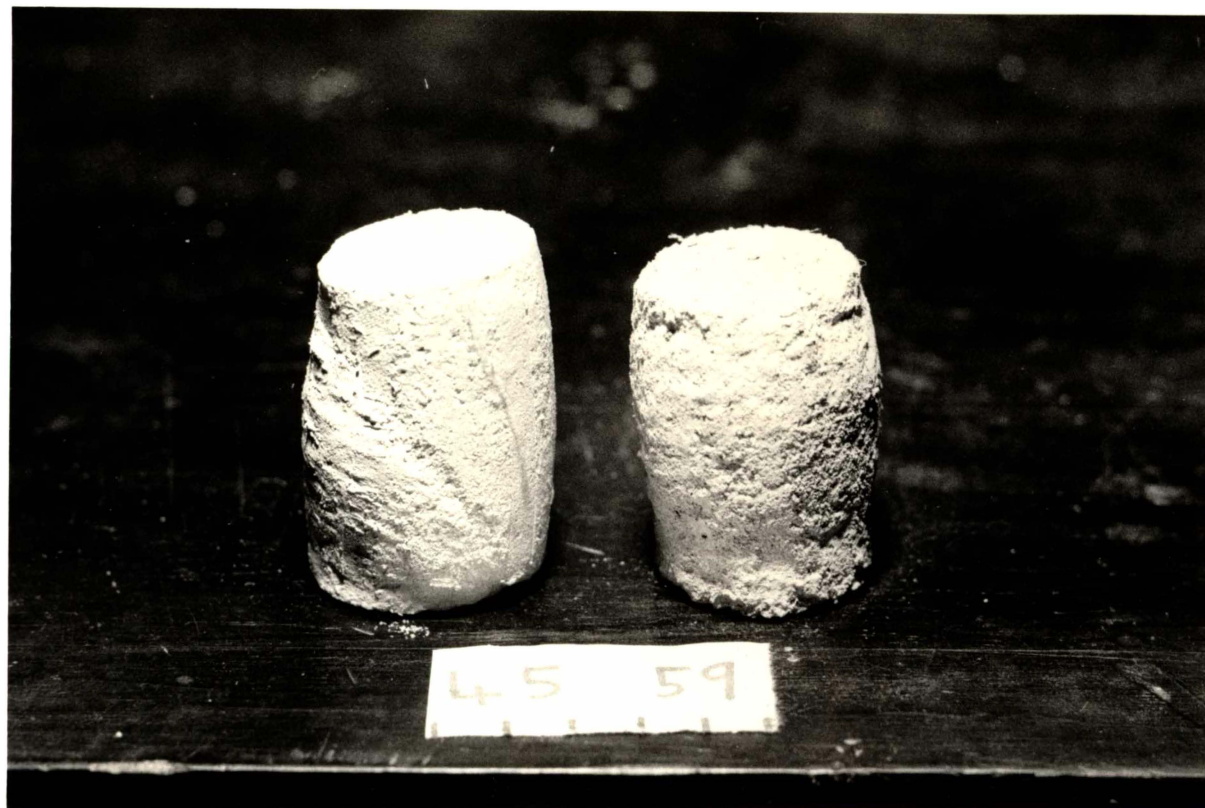
Fig 4.12 Triaxial shear samples from tests 45 (sandy mud, brittle failure) and 59 (silty sand, plastic failure).
